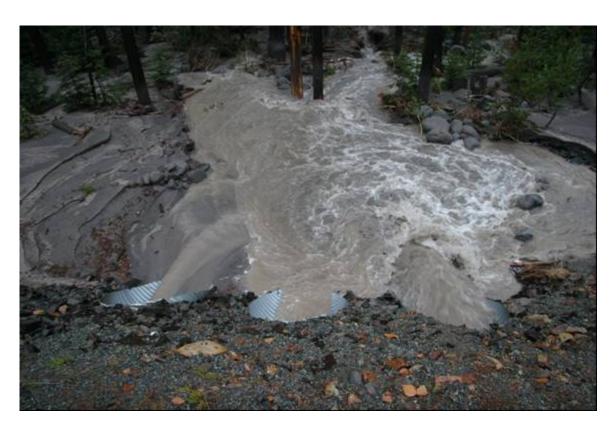
Mineral Creek Emergency Culverts at work. Main culvert plugged. 2 of 3 new culverts plugged. This is across the road from White River Boy Scout Lodge. About 1/3 of White River is here

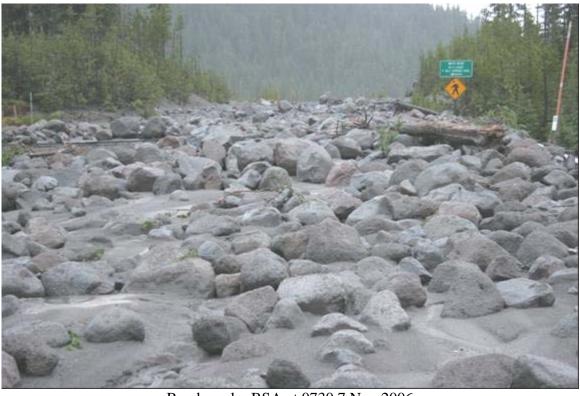
Roadway by BSA at 0730 7 Nov 2006

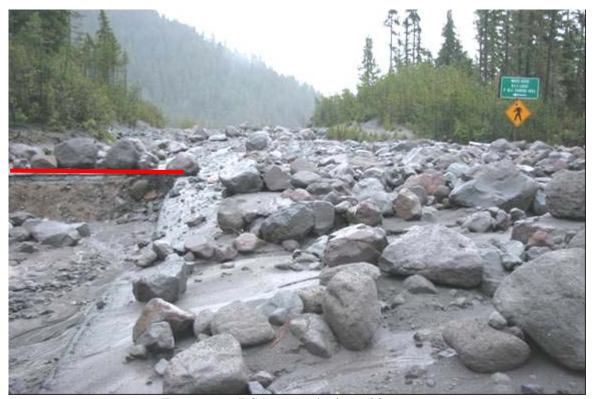
Entrance to BSA snopark about 20% gone

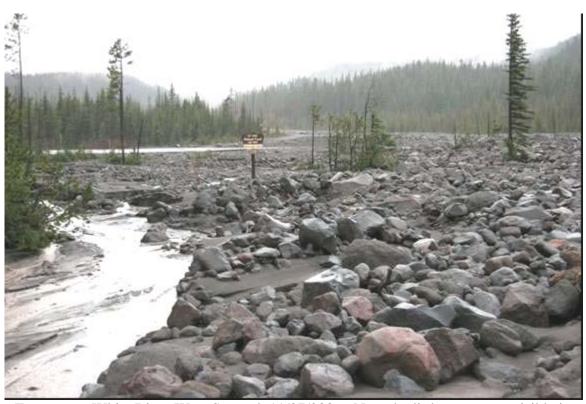
Entrance to White River West Snopark 11/07/2006. Note the little pavement visible in background. This SnoPark will <u>NOT</u> be available this winter!

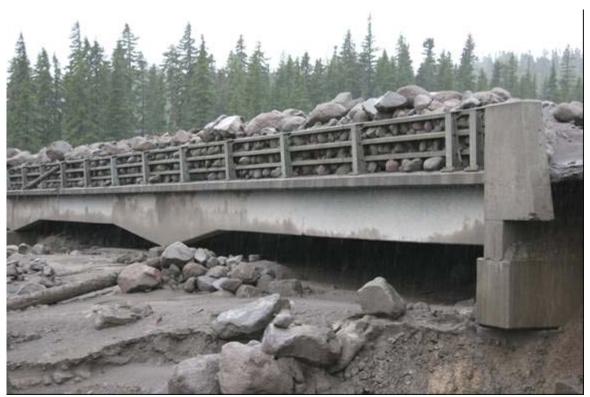
Down River Side of White River Bridge. The top of the pile on the bridge is level with the upstream side of the bridge meaning about 15-20 ft of fill.

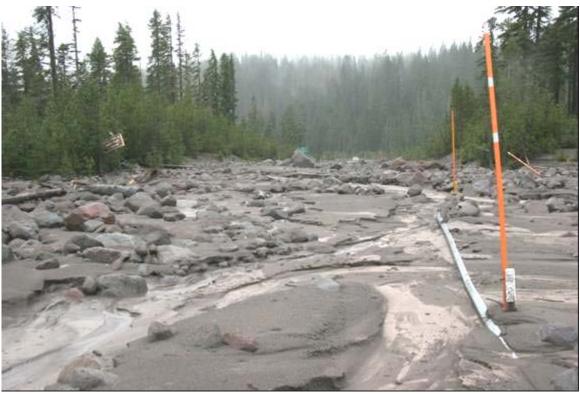
Photo taken from middle of White River bridge looking south. Guardrail and snowpoles mark the upstream side of the bridge! You should be looking down about 15 feet on the right side to where the river is supposed to be.

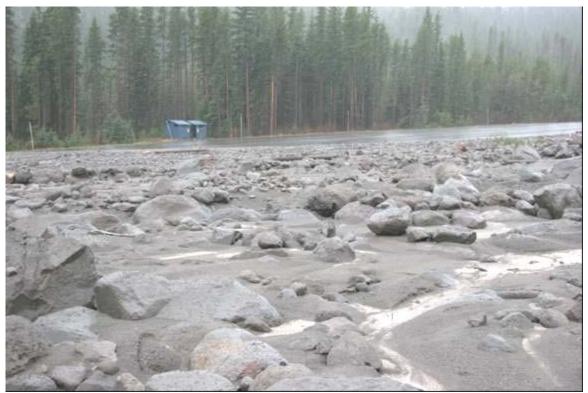
What's left of the snopark

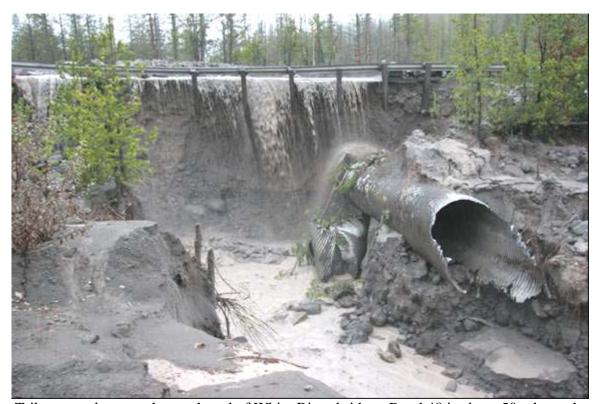
Tributary culvert on the north end of White River bridge. Road 48 is about 50 yds north, to the right. About 2/3 of White River is here.

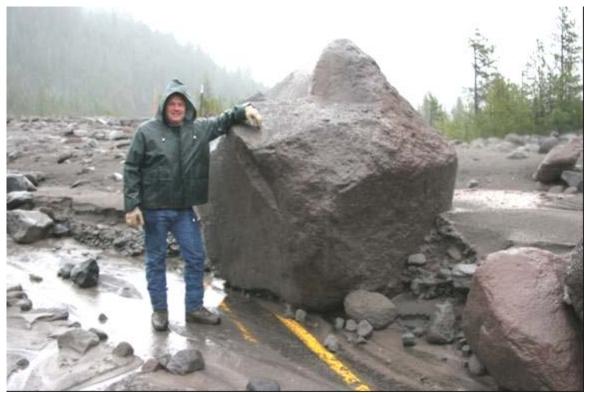
Rather large boulder left on centerline of Hwy 35 in front of Boy Scout Lodge. Little White River can move big things when it has the mind. This is Gary about to fire up his D-8

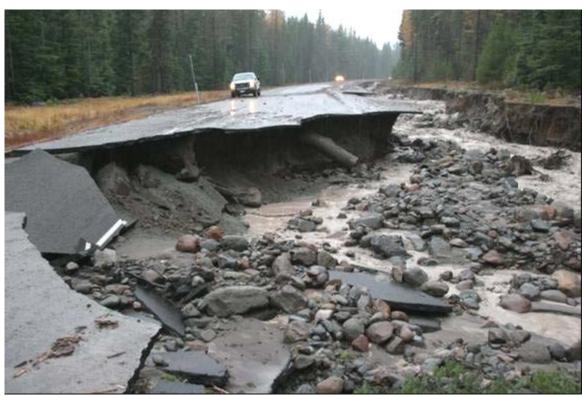
Hwy 35 just south of Pocket Creek snopark. This is Clark Creek flowing along the Westside of the highway toward Newton Creek box culvert where it crosses the road. Newton Creek is now where it was in the last event!

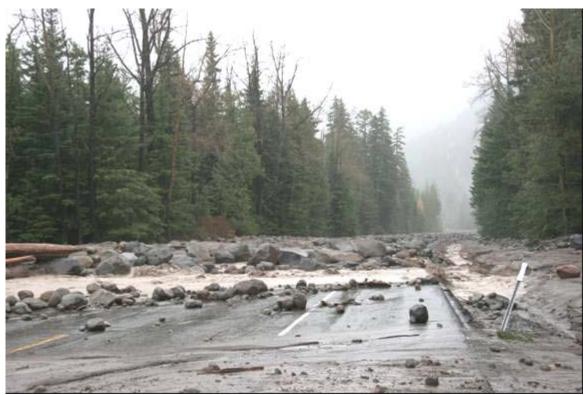
Looking north toward Robinhood. The Robinhood bridge is around the corner in the distance. This is Newton Creek crossing the road and running along the eastside of the highway.
